# Investigation of High Back Pressure on HPLC

Steven M. Caldwell  
Dr. Malesia Langston

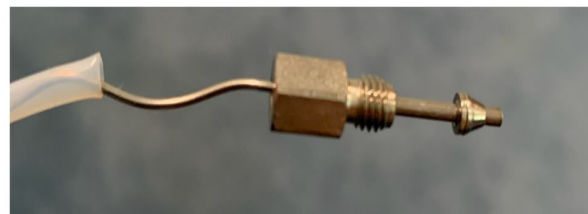
However, it was suspected that the back pressure build up was a compounded error. This meant that there may have been multiple locations that were creating a pressure increase. The first and easiest procedure to correct a pressure build-up is to clean out the tubing from the HPLC column to the detector, and the tubing leading to the injector. Interestingly, the stainless steel frit that was connected to the injector snapped for some unknown reason – being stainless steel this should not have happen. The broken frit is shown in figure 2a (left side) and the intact frit is shown in figure 2b (right side).

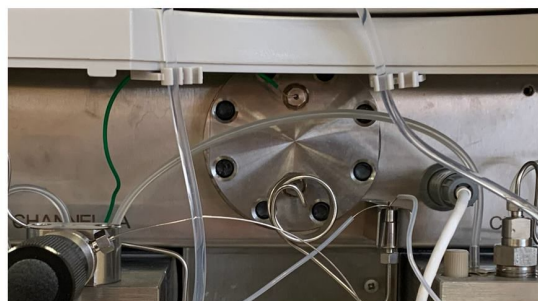
The tubing in where the pumps are located were not cleaned. It was suspected that the pulse dampener was malfunction - this yet is to be determined. The pulse dampener is shown below

The cause of the back pressure error is currently unknown. Further investigation will include replacement of the pulse dampener and the recleaning of all tubing in the system. Additionally, if the problem is not resolved with these additional steps, then a trained technician will be required to investigate and validate all technical hardware or software issues
